Fuel Leak Simulation

**Dr. Michael R. Swain
University of Miami
Coral Gables, FL 33124**

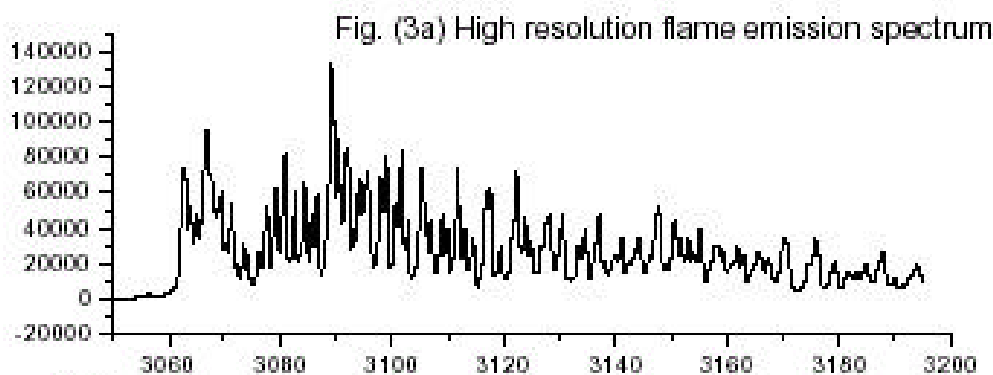
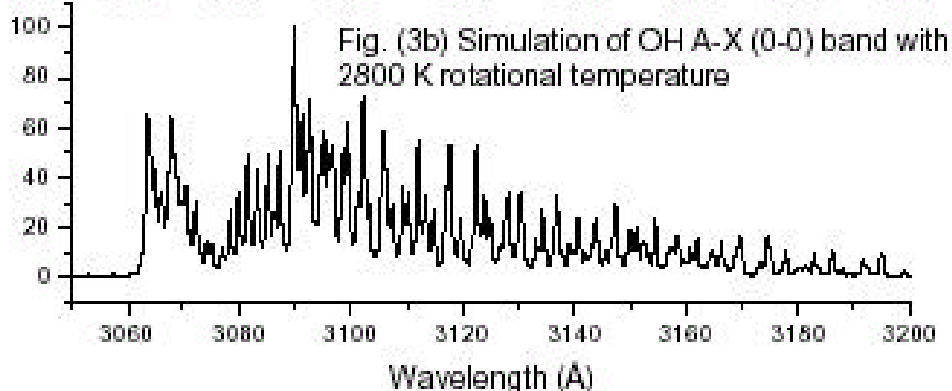
Figure (3a) shows a high-resolution spectrum of a portion of the 3000 Å feature. It can be seen that, in contrast to the sodium D lines we have a complex multi-line spectrum. This is characteristic of the spectrum of a simple diatomic or polyatomic molecule and the relatively open structure suggests a hydride. The strong emission spectrum of the OH A $^2\tilde{O}-X$ $^2\tilde{D}$ (0-0) band lies in this region. This emission is characteristic of H_2/O_2 flames and has been extensively observed and characterized. A quantitative identification requires a computer simulation of the spectrum. Figure (3b) shows a simulation of the OH A-X (0-0) emission spectrum assuming a rotational temperature of 2800 K and a spectral resolution of 0.6 Å. The simulation clearly identifies the experimental feature as being due to OH. We have not attempted to identify the broad infrared spectral feature. Several sets of high and low-resolution spectra were obtained and this involved relighting the flame several times. It is an extremely turbulent diffusion flame

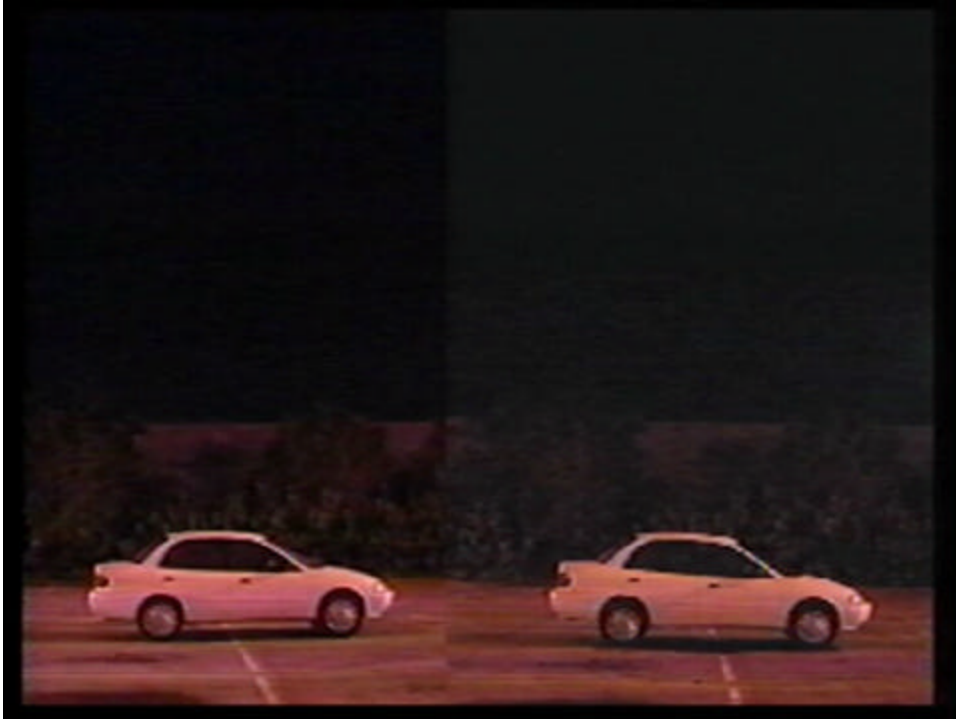
Photo 1 - Time: 0 min, 0 sec - Hydrogen powered vehicle on the left. Gasoline powered vehicle on the right.

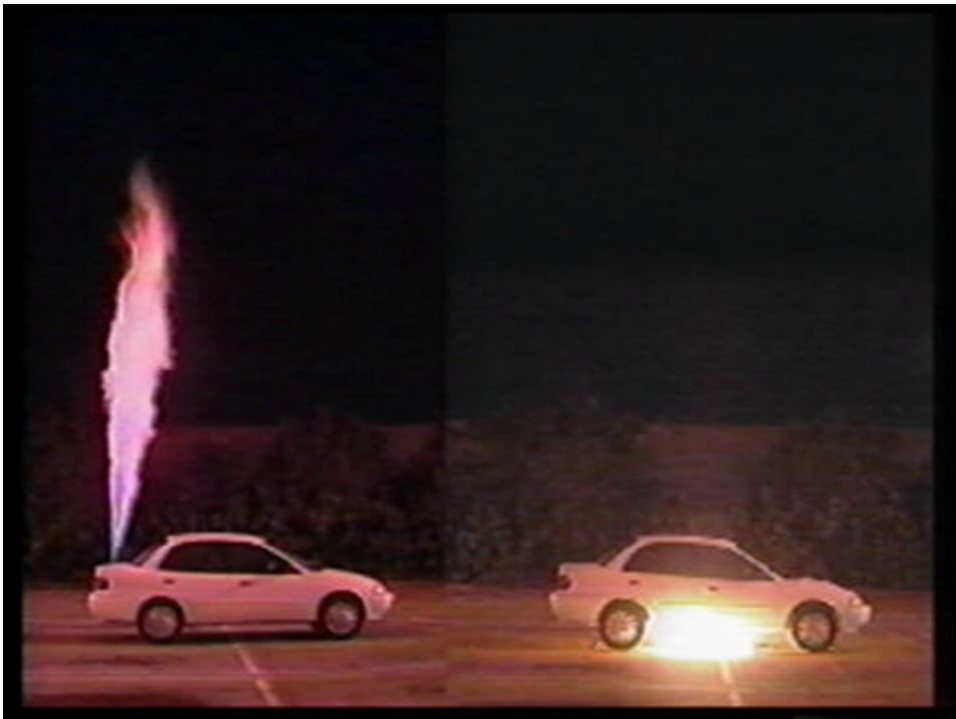
Photo 2 - Time 0 min, 3 seconds - Ignition of both fuels occur. Hydrogen flow rate 2100 SCFM. Gasoline flow rate 680 cc/min.

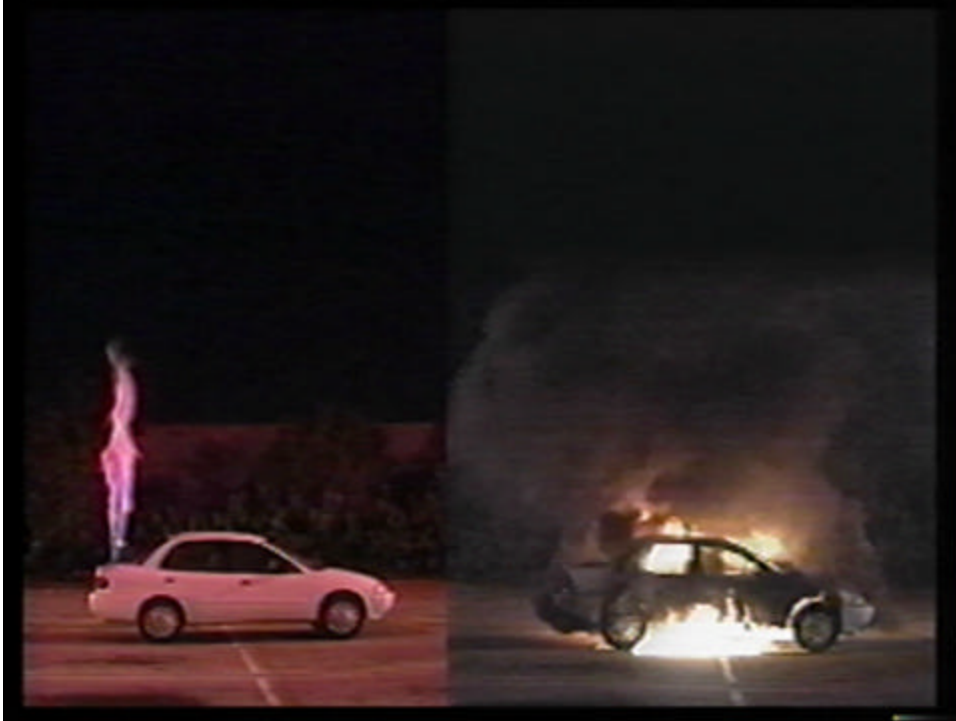
Photo 3 - Time: 1 min, 0 sec - Hydrogen flow is subsiding, view of gasoline vehicle begins to enlarge

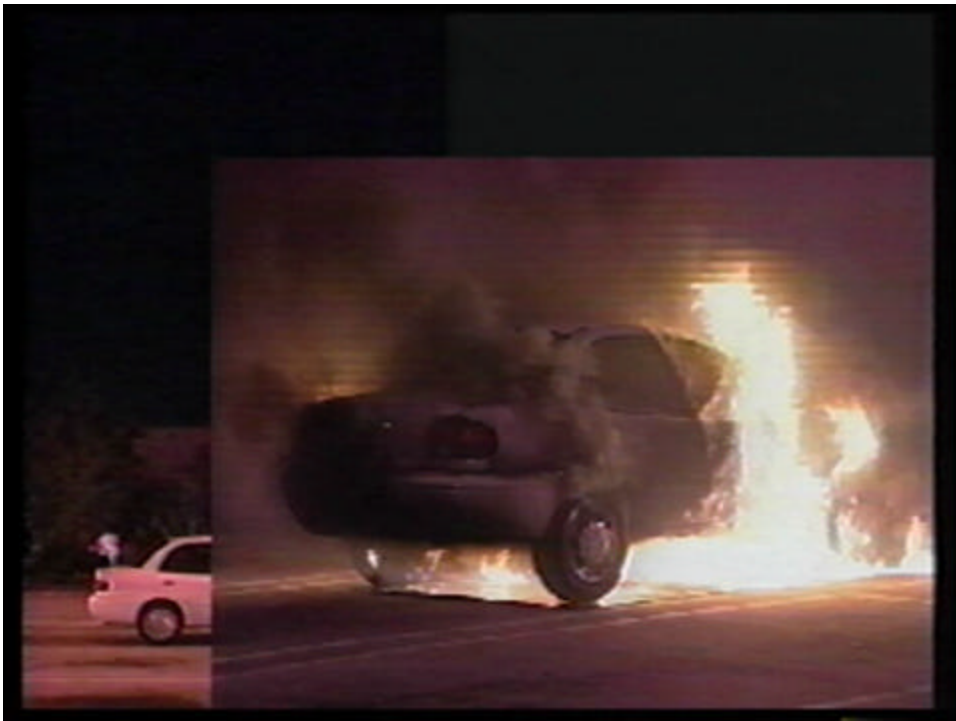
Photo 4 - Time: 1 min, 30 sec - Hydrogen flow almost finished. View of gasoline powered vehicle has been expanded to nearly full screen

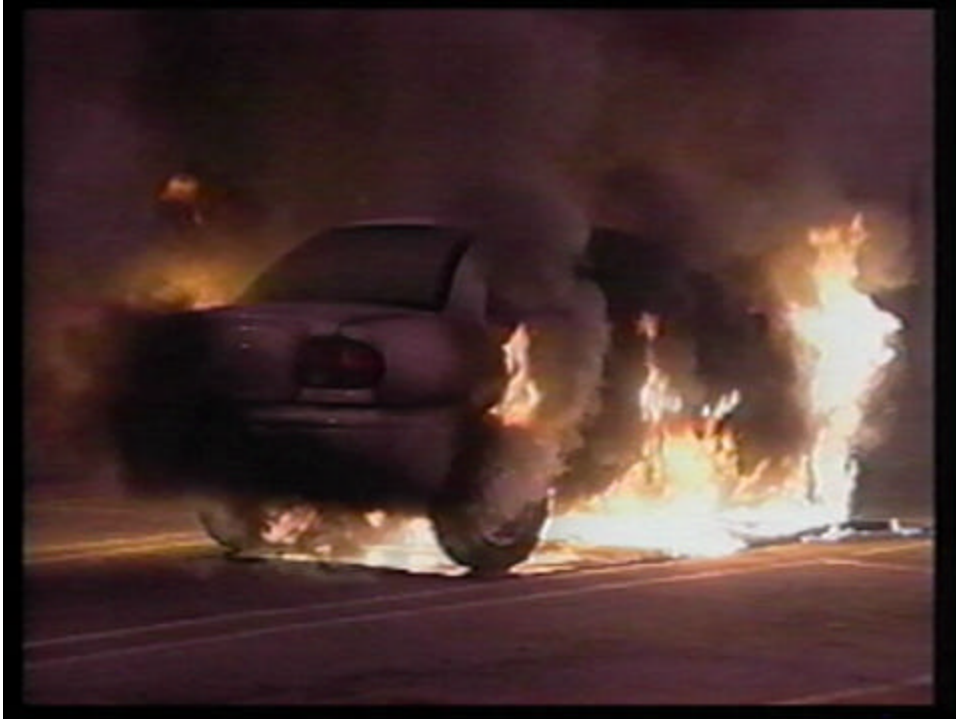
Photo 5 - Time: 2 min, 20 sec - Frame prior to interior deflagration.

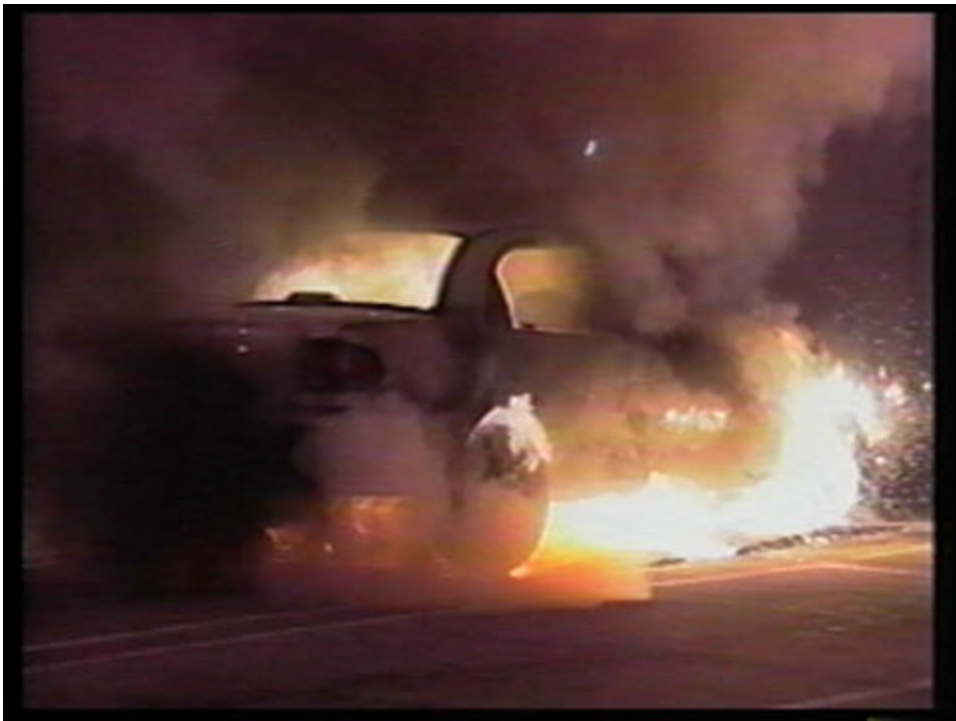
Photo 6 - Time: 2 min, 20 sec - Deflagration in the interior, following frame shows flames exiting around edges of trunk lid.

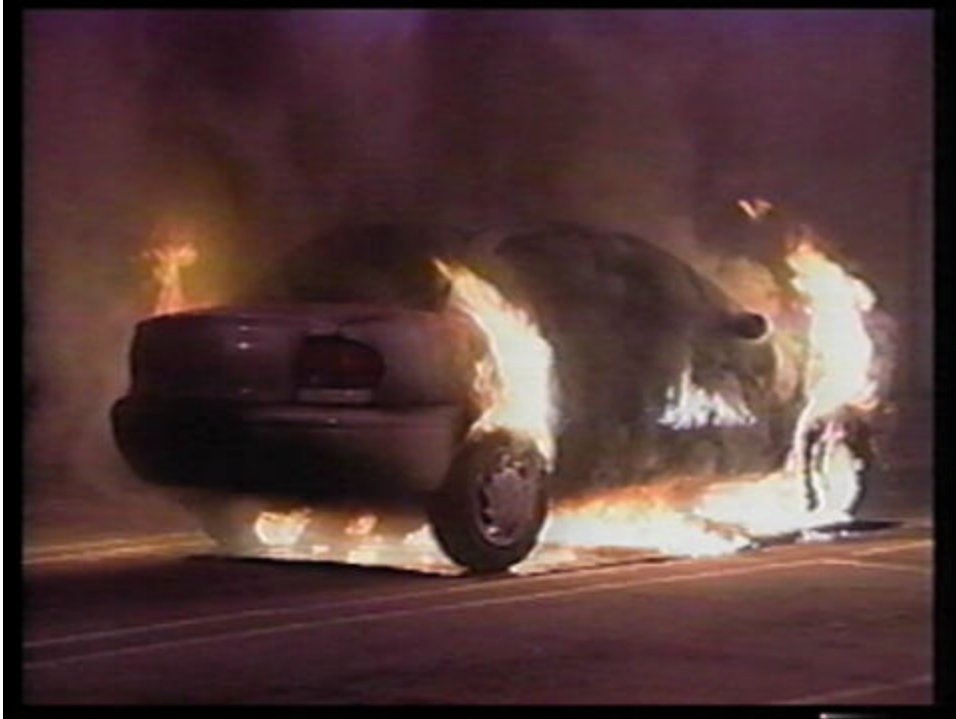
Photo 7 - Time: 2 min, 40 sec - Frame prior to driver's side rear tire rupture.

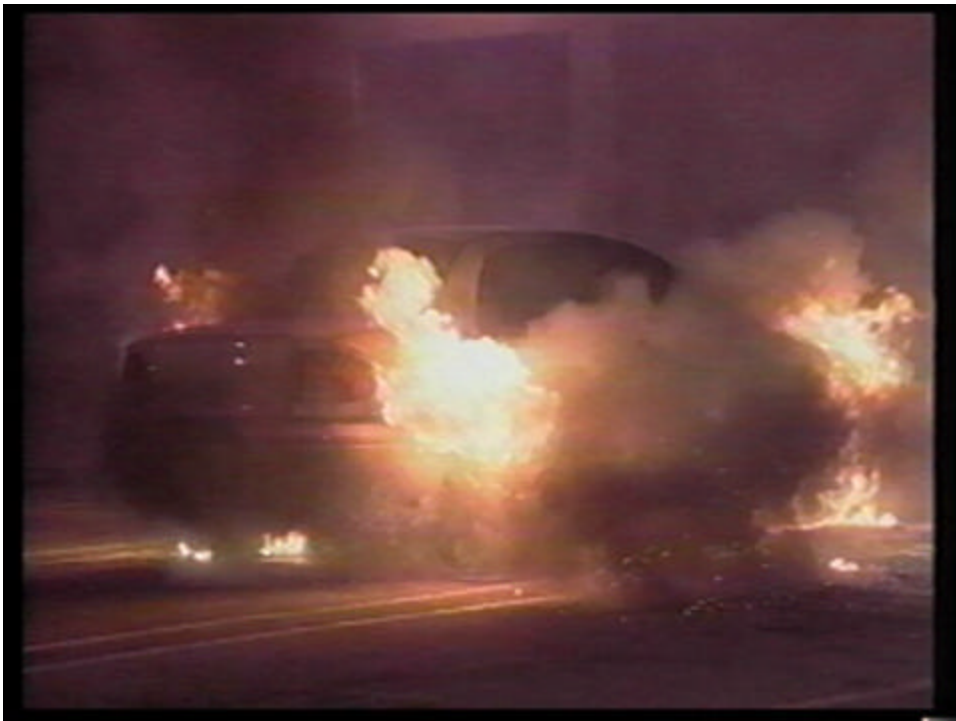
Photo 8 - Time: 2 min, 40 sec - Driver's side rear tire rupture sends debris out the passenger side of the vehicle.
